# Thermography Applied to Old Masonry Constructions

*Rubén Rodríguez Elizalde*

## Abstract

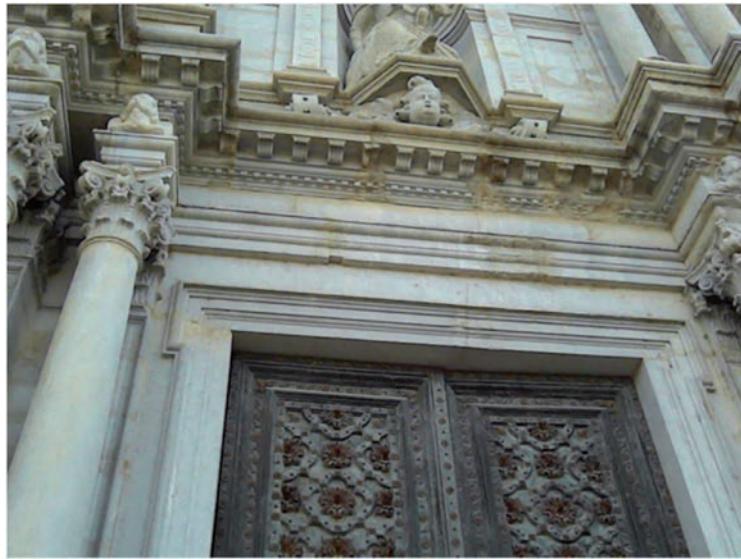
**Figure 7.**

Photographic image of the entrance to Girona Cathedral on its western facade (photo by the author).

Thermogram of the image in **Figure 7**, illustrating the distinct materials (photo by the author).

This distinction becomes even more pronounced when dealing with materials of markedly different nature. A clear example can be observed in the entrance door of Girona Cathedral (**Figure 7**), located on its western facade. Amidst the stone ornamentation made of limestone rock, the entrance door, being metallic, displays a stark contrast in the thermogram (**Figure 8**) due to the difference between the sedimentary rock of the facade and the metal of the door.

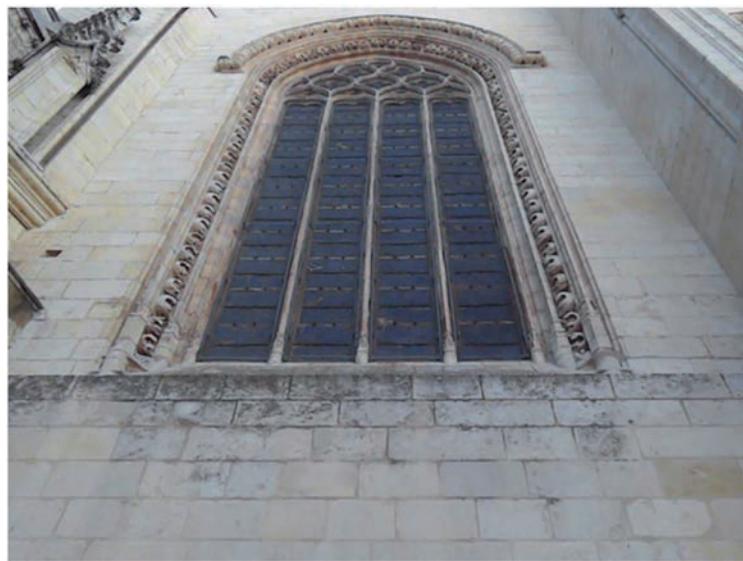
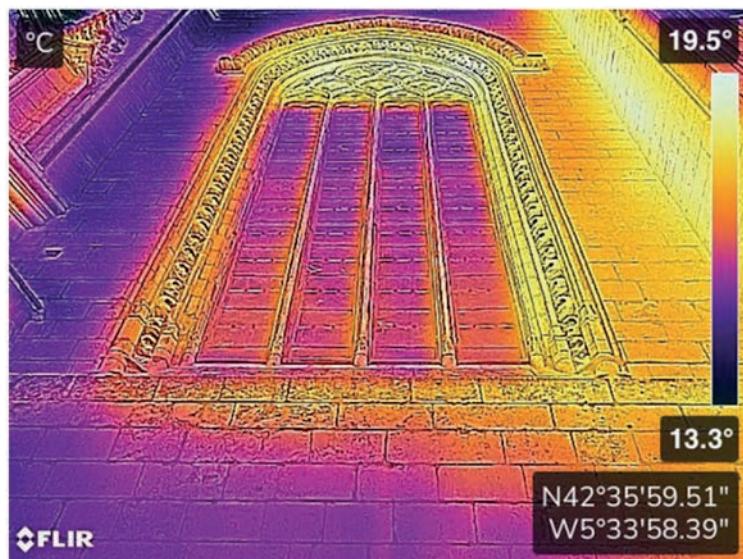
**Figure 9.**  
Photographic image of the eastern apse of León Cathedral (photo by the author).

**Figure 10.**  
Thermogram of the image in **Figure 9**, highlighting the material differences (photo by the author).

The Cathedral of León is globally renowned for its stained-glass windows. Beyond their decorative function, these tinted glasses were strategically placed to allow sunlight to illuminate the temple's interior. Consequently, the difference between the limestone of the walls and the glass of the windows is substantial in terms of transmission, emission, and reflection. From the outside, significant differences become apparent in both the photographic image (**Figure 9**) and the corresponding thermogram (**Figure 10**). Particularly interesting in this regard are the thermal readings captured around the edges of the windows.

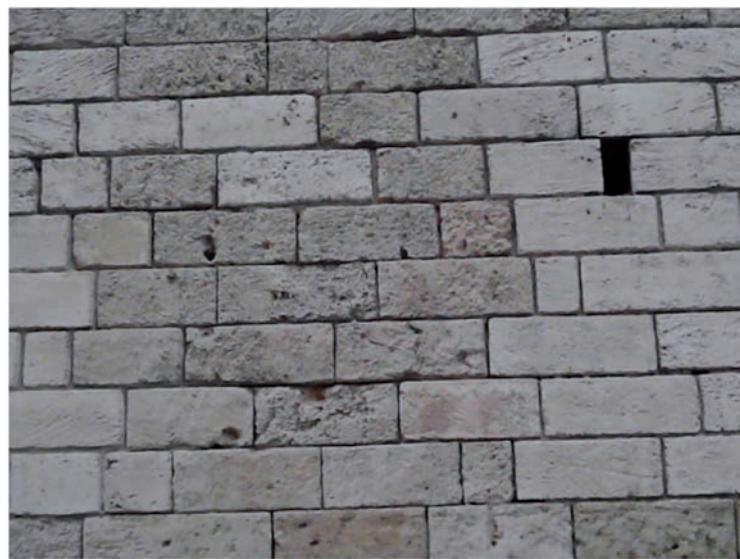
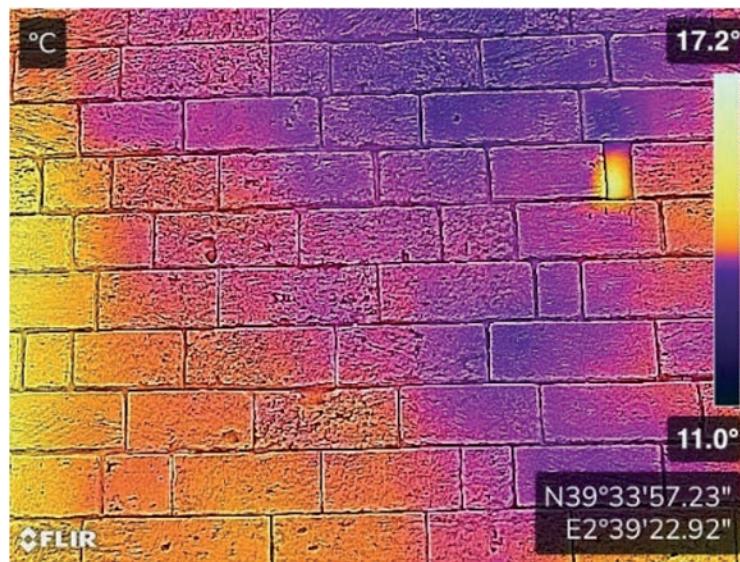
**Figure 11.**

*Detail of the south façade wall of the Cathedral of Palma de Mallorca, where different ashlars from the Marés can be seen (photo by the author).*

*Thermogram of the image in Figure 11, highlighting the material differences (photo by the author).*

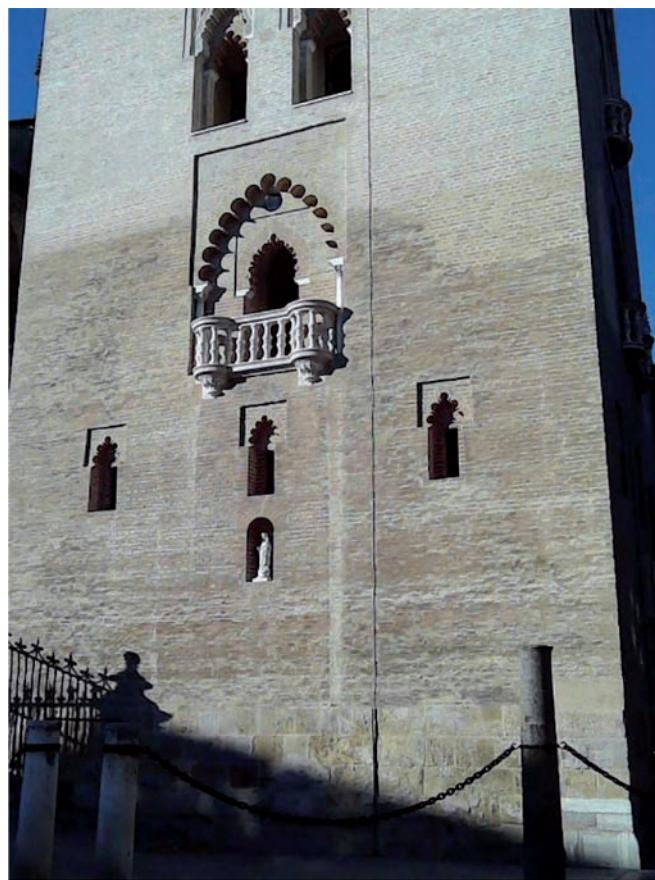
**Figure 15.**

*Photographic image of the lower eastern facade of La Giralda in Seville Cathedral, revealing moisture issues (photo by the author).*

**Figure 16.**  
Thermogram of the image in Figure 15, showing varying moisture levels in the brickwork (photo by the author).

Another illustrative example can be found in the lower section of the eastern facade of La Giralda, the bell tower of Seville Cathedral. Despite its recent restoration [11], issues related to the brickwork, particularly moisture problems, persist. These issues are visible to the naked eye in the photograph (**Figure 15**) but become even clearer in the thermographic image, where areas affected by moisture are

distinctly identifiable. Given the operational principles of thermography, it is logical to expect that moist areas would appear warmer than dry ones due to evaporative cooling (**Figure 16**). Nevertheless, this is not always the case, as thermal history can sometimes obscure useful signals, as observed in the lower rows of the bell tower of Valencia Cathedral, the Torre del Miguelete (**Figure 16**). Here, the varied degrees of moisture absorption, resulting from poorly executed restorations with

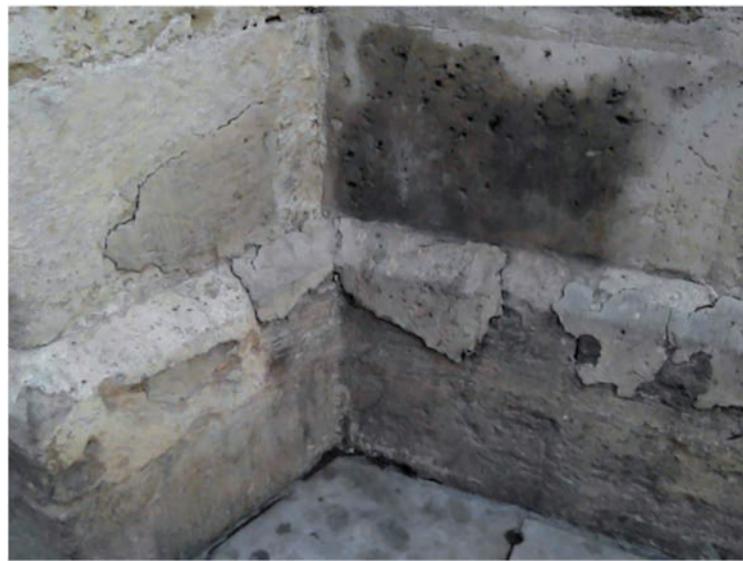
**Figure 17.**  
Detail of the southeast facade base of the Torre del Miguelete in Valencia Cathedral, showing diverse materials and varying deterioration states (photo by the author).

**Figure 18.**  
Thermographic analysis of the materials from **Figure 17**, revealing the differences captured by the camera (photo by the author).

unsuitable materials [3], are accurately detected by the thermographic camera (**Figures 17 and 18**).

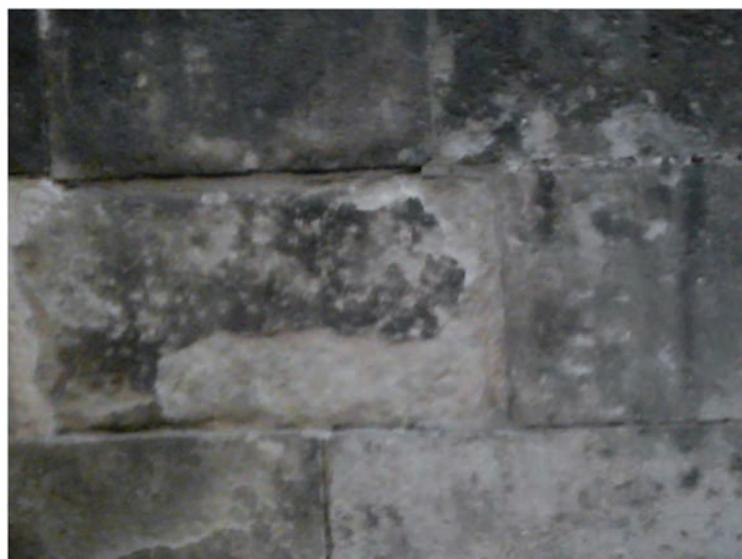
**Figure 19.**  
Black crusts on the sandstone ashlar of the facade of the Cathedral of Barcelona (photo by the author).

**Figure 20.**  
Thermographic analysis of the ashlars in **Figure 19**, reflecting the black crusts photographed (photo by the author).

Similar phenomena can be observed in the stone blocks of Barcelona Cathedral's facade. The Montjuic sandstone [12] exhibits deterioration caused by the synergistic action of chemical and biological agents, notably the formation of black crusts (**Figure 19**), presumably linked to sulfur compounds from urban pollution [3]. This

phenomenon is unsurprising given the monument's central location in one of Europe's busiest cities. The restriction of traffic near the Cathedral is relatively recent, considering the building's age. Some of these lesions manifest distinctly in the corresponding thermogram (**Figure 20**).

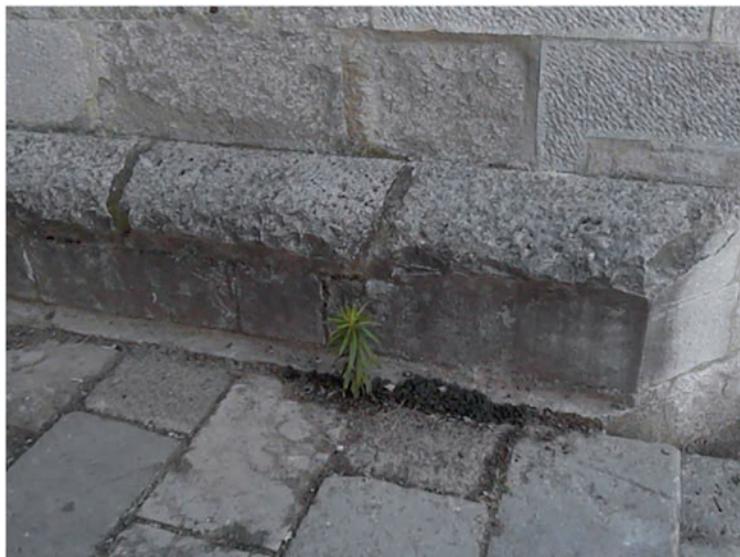
**Figure 21.**  
Detail of the lower eastern facade of the Basilica of Sant Feliu, with visible vegetation growth (photo by the author).

**Figure 22.**  
Thermographic analysis of the image from Figure 21, showing the material differences detected by the camera (photo by the author).

When biological growth, such as plants, takes root in the joints between blocks, especially at angular points [3], their action exacerbates moisture issues, efflorescence, and runoff stains. These patterns are visible in both the photograph

(Figure 21) and thermogram (Figure 22) of the western facade of Girona's Basilica of Sant Feliu [13].

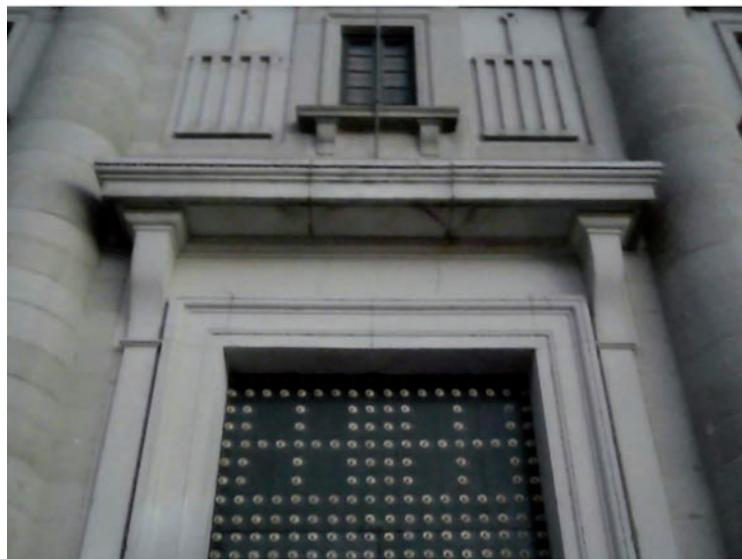
**Figure 24.**

Ground-level photograph of the lintel above the main entrance of the Monastery of El Escorial (photo by the author).

Terrestrial thermogram corresponding to Figure 24, showing the different materials used (photo by the author).

Modern thermographic software incorporates these corrections by default, enabling more accurate temperature measurements. Users must input values for surface emissivity, relative humidity, air temperature, distance to the object, and background temperature (**Figure 24**). The latter can be estimated by measuring the temperature of a crumpled aluminum foil piece placed between the camera and the object, assuming maximum emissivity ( $\epsilon = 1.00$ ) (**Figure 25**).

A noteworthy example is the main entrance of the western facade of the Monastery of San Lorenzo de El Escorial, whose fracturing has been meticulously studied [18]. Thermography proved highly useful in investigating whether this fracture, which has a structural explanation, could pose durability issues. To this end, terrestrial thermography was initially employed. However, despite conducting the thermographic inspection, the significant height of the lintel (over 6.00 m) prevented obtaining conclusive results due to the limited viewing angle.

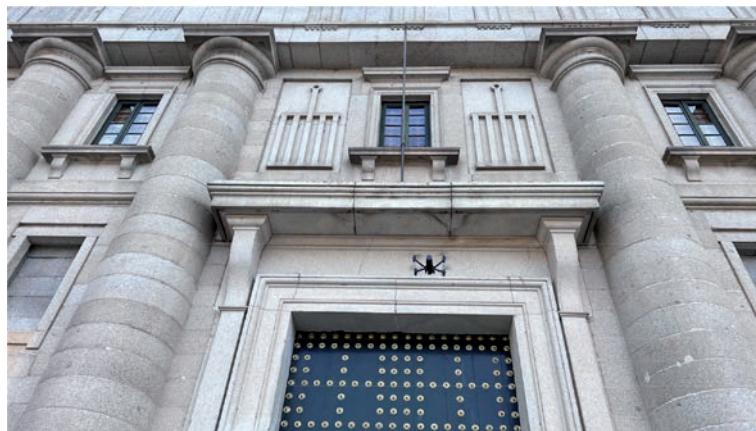
**Figure 26.**  
Drone hovering in front of the lintel of the main entrance of the Monastery of El Escorial (photo by the author).

**Figure 27.**  
Aerial thermogram, captured with a drone, of the lintel above the main entrance of the Monastery of El Escorial (photo by the author).

For this reason, aerial thermography was employed: a drone was deployed to capture the corresponding thermogram, which clearly demonstrated the homogeneity of the lintel's constituent material and, consequently, the absence of durability-related damage associated with the existing fractures. The difference between the images obtained through aerial and terrestrial thermography is significant (**Figures 26 and 27**).

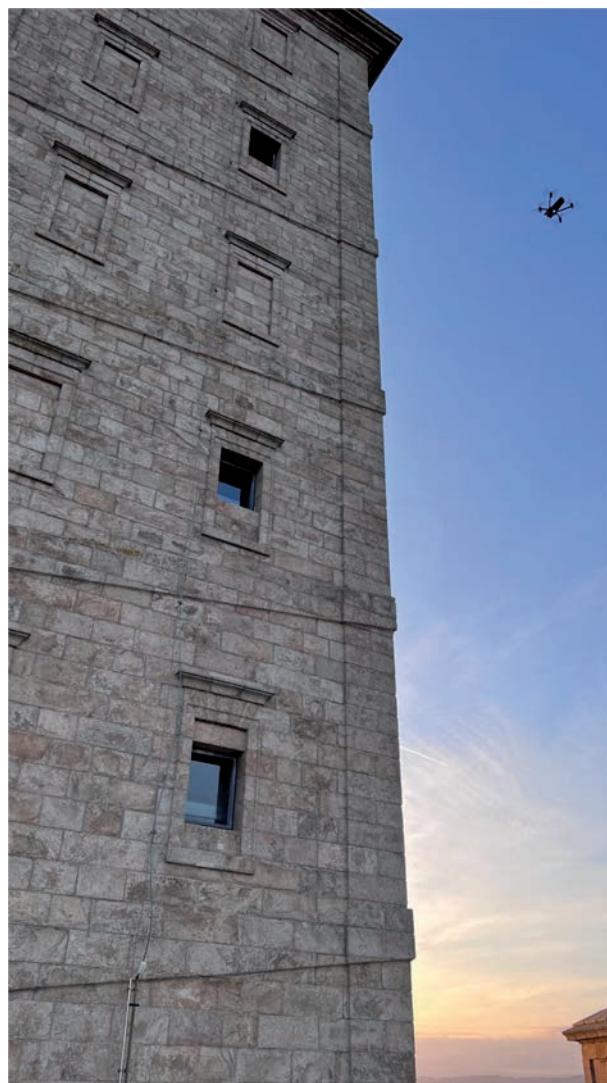
**Figure 28.**

Drone flying alongside the Tower of Hercules to capture photographs and thermograms (photo by the author).

Another compelling example is the Tower of Hercules, previously mentioned in the context of terrestrial thermography (**Figures 13 and 14**). Given its height of 55 m [19], terrestrial thermography is evidently limited. Therefore, a drone was deployed to conduct the necessary reconnaissance operations and capture the required thermograms (**Figure 28**). The drone facilitated a detailed analysis of the neoclassical lantern atop the tower, where the most thermally significant points were identified

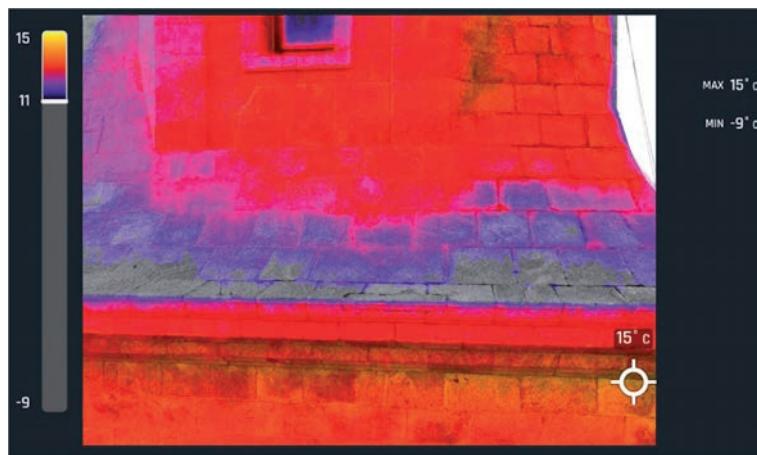
**Figure 29.**  
Junction between the original Roman section and the lantern added in the eighteenth century, highlighting the area with the highest recorded temperature (photo by the author).

**Figure 30.**  
Thermogram analyzing the lantern atop the tower, marking the point of maximum temperature (photo by the author).

(**Figures 29 and 30**). Additionally, a comprehensive examination of the facade was performed, with the drone positioned at various points to capture images from appropriate heights (**Figures 31–33**). The thermographic analysis confirmed the absence of significant anomalies, although minor irregularities were observed in some stone blocks, attributable to weathering effects on the granite (**Figure 32**). These irregularities are negligible and pose no durability concerns.

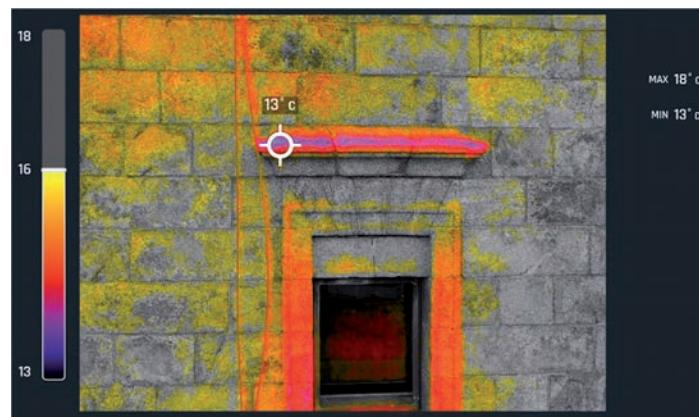
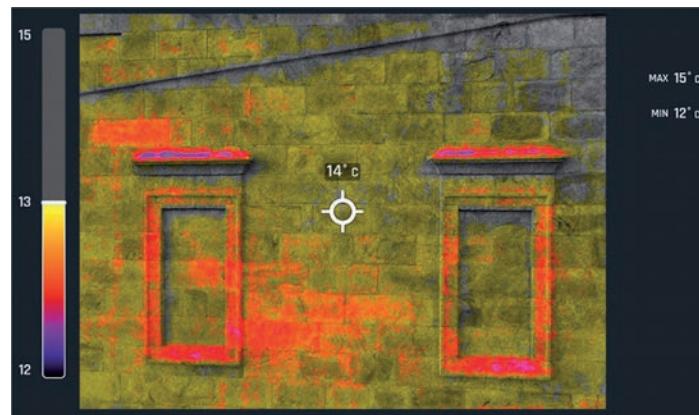
**Figure 31.**

Thermogram captured by the drone to analyze the window of the first-level chamber on the northern facade, indicating the point of minimum temperature (photo by the author).

Thermogram captured by the drone analyzing the opaque windows of the top level on the northern facade (photo by the author).

Thermogram captured by the drone examining the highest window on the northern facade (photo by the author).
